Editorial

This edition of **CHIRP** Maritime Feedback covers a wide range of incidents, and it is encouraging to see reports from the leisure and fishing sectors. Please keep them coming!

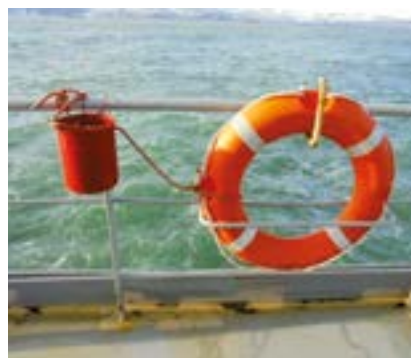
Who hasn't seen lifebuoy lines get into a tangle which would cause problems if the lifebuoy needed to be rapidly deployed? Here is a simple solution where the rope is coiled in a container and "stored" ready for immediate release.
