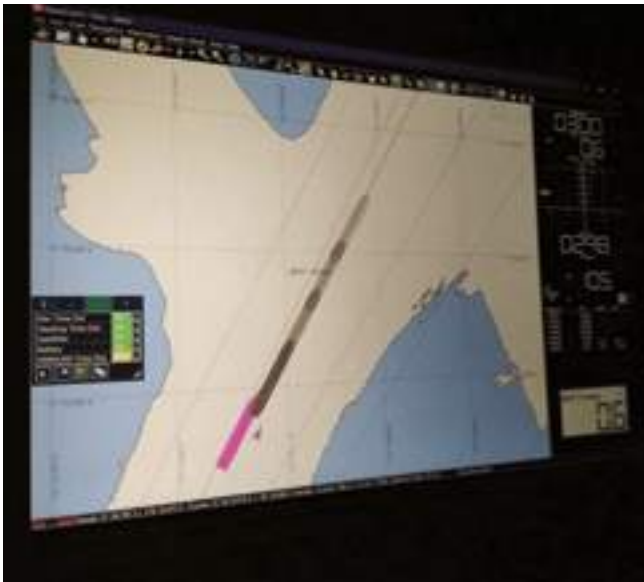
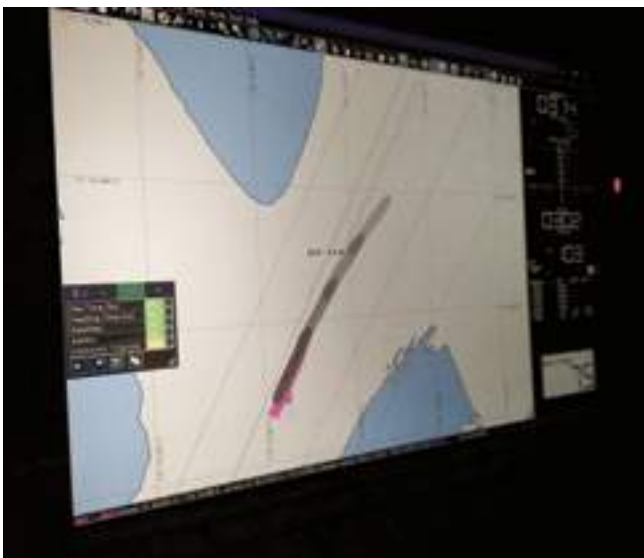
Upon arrival in port, I observed that the AIS data was showing the vessel behind the data presented on the PPU. Whilst passing a beacon, I asked the master to tell me where it was from looking at the ECDIS, "On the port bow" was the answer, but it was actually on the beam. After the vessel was secured alongside, there was no error.

I asked the Captain if it was possible to look at the settings on the GPS. We found under GPS SETUP, a section called GPS SMOOTHING which allowed for data entry. The "Position" was set at 20 seconds, "Speed" at 30 seconds and "Average Speed" at 120 seconds. The master reset them all to zero and confirmed that the result had been effective with accurate positions displayed following departure.

PPU showing GPS smoothing (top) with vessel "lagging" and smoothing removed (bottom)

With respect to GPS smoothing, **CHIRP** issues a note of caution. The removal of all smoothing may well have solved the position lag in the third report, but smoothing does have a purpose. It can affect course over the ground (COG), course made good (CMG) and time to go to an alteration point (TTG). Thus, it is important to build in the necessary checks and balances for this vital equipment, as reliance on ECDIS and other electronic equipment can and will only increase – this factor will become increasingly important with the advent of autonomous shipping.

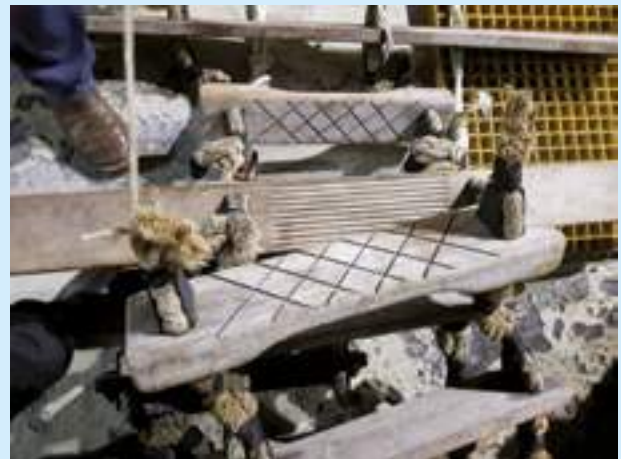
Reports being properly actioned so as to prevent a repetition might put an end to situations like the one illustrated below. In this scenario, the pilot actually placed his weight on the ladder and the ropes simply collapsed. Fortunately, this was whilst testing the ladder prior to disembarkation, but had this not been the case then the consequences might have been tragically different.

Deathtrap – pilot placed his weight on this ladder prior to disembarking and both side ropes parted!!
