UK P&I CLUB

RISK FOCUS: ENGINE ROOM FIRES

The majority of onboard fires originate in the engine room

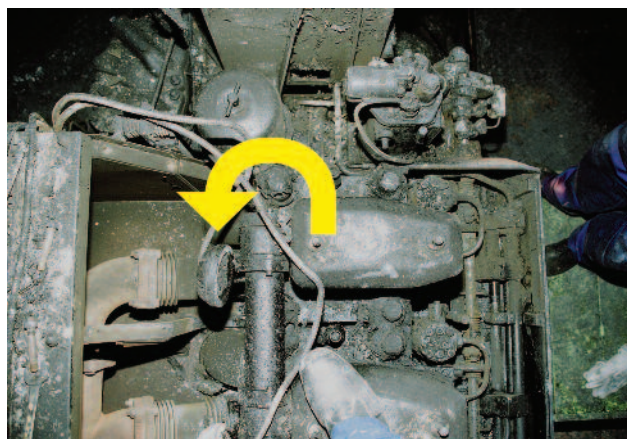
Potential route for hot oil vapour to spread from the hot box enclosure to the exhaust enclosure (cladding/covers removed for inspection)

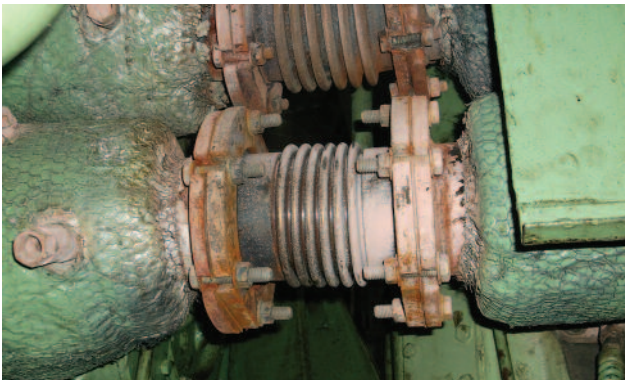
Exhaust bellows exposed

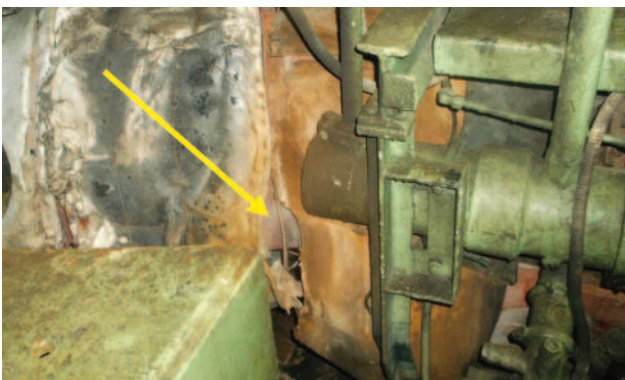
Small portion of exhaust surface exposed (as arrowed)

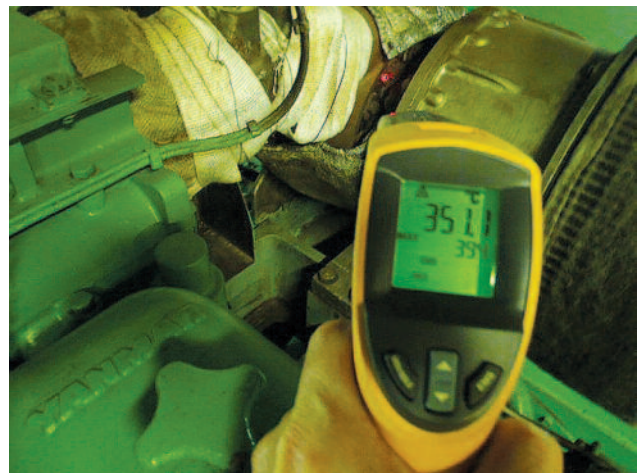
"Hot spot" due to missing insulation

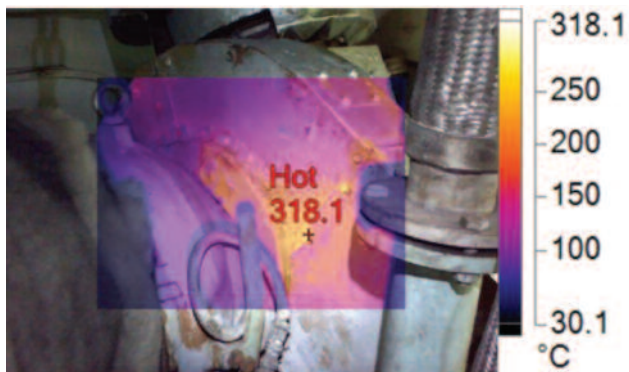
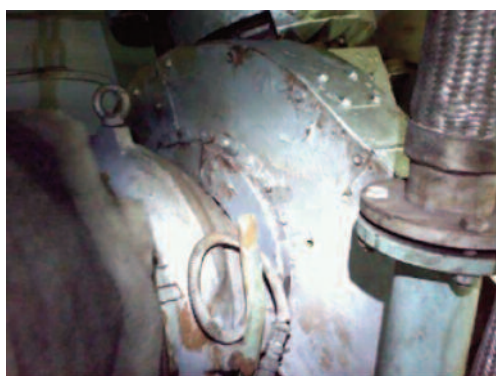
IR001153.IS2-NO1 Auxiliary engine

Alternatively, surveys can be carried out by using more expensive thermal imaging equipment which provides a clear image of the surface temperature profile as illustrated in the example below, where the thermal image is compared with the visible light image.

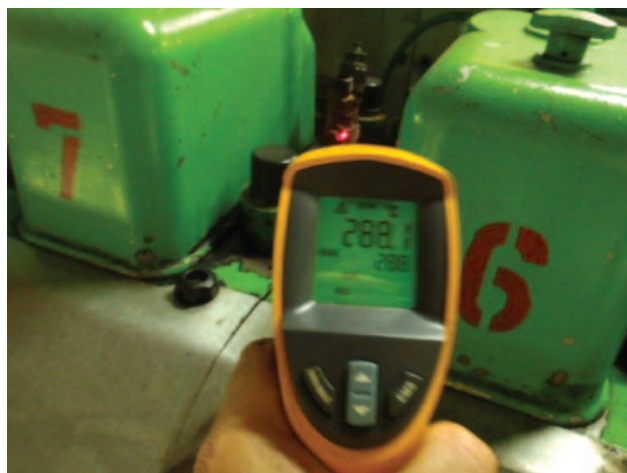
Indicator cocks are another potential source of ignition. IMO MSC.1/Circ. 1321 Para 1.1.5 recommends that "Exposed indicator cocks should be insulated in order to cover the high temperature surface."

Uncovered indicator cock with exposed temperature above SOLAS limit

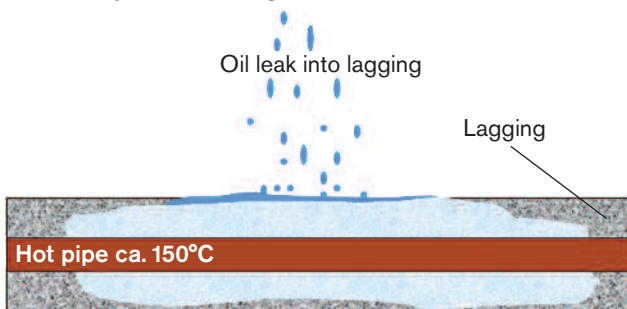
If mineral oils (fuel oil, diesel oil, lube oil) soak into lagging on pipe work operating at a temperature above about 150°C there is a risk that the oil will oxidise slowly within the matrix of the lagging and eventually ignite spontaneously, causing the lagging to disintegrate and oil from a persistent leak to ignite. This process can take many hours, and there may be little external warning of the imminent danger until smoke appears shortly before the fire becomes visible. It is essential, therefore, that oil leaks are attended to promptly and that permanent repairs, including the replacement of oily lagging, are made correctly rather than resorting to makeshift solutions.

Risk of 'spontaneous ignition'

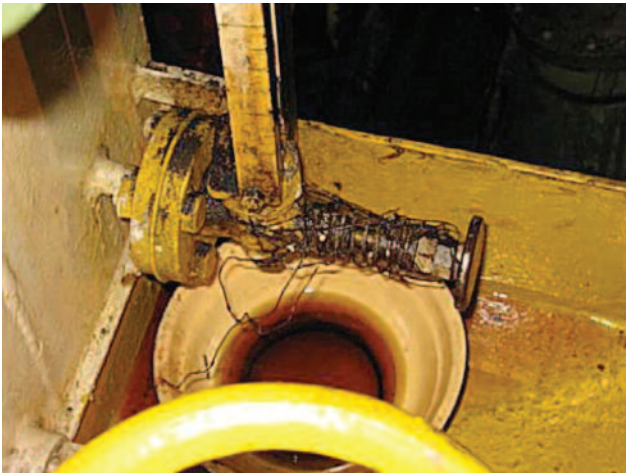
The UK Club's ship inspectors regularly find that various methods are used to keep these valves permanently in the open position. Chocks of wood, pieces of wire and purpose made clamps are often seen to be used to for this purpose. This is dangerous practice. If a gauge glass breaks in a fire the entire contents of the tank will leak into the burning area, escalating the fire.

Self-closing gauge glass valve gagged with wire

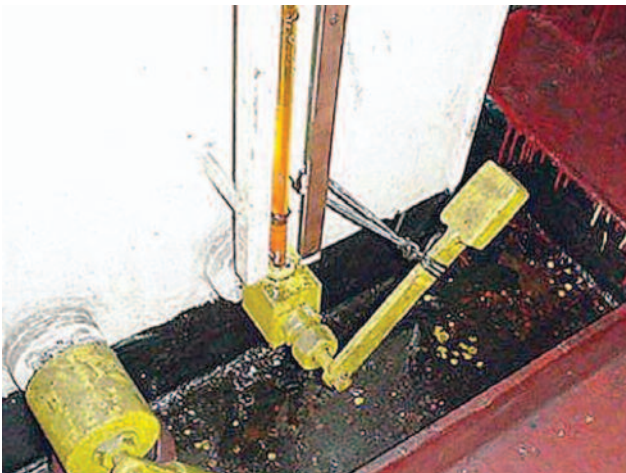
Self-closing gauge glass held open with string

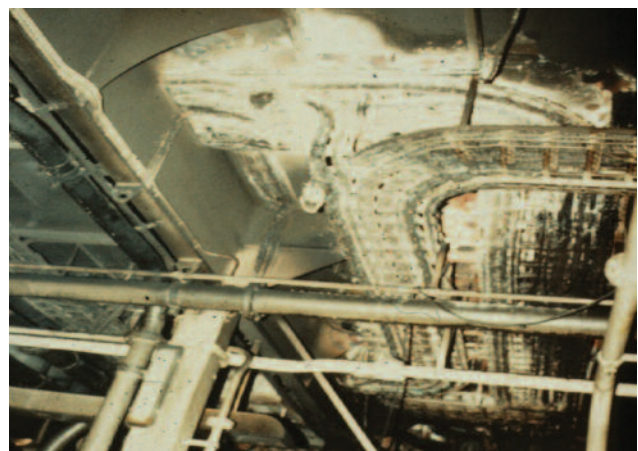
Damage caused by the spread of fire along cable trays after being exposed to a fire at a lower level of the engine room.

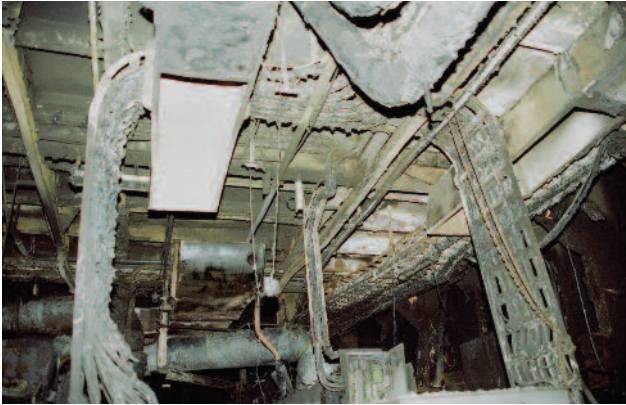
Fire spread along cable trays away from an auxiliary generator where the fire originated

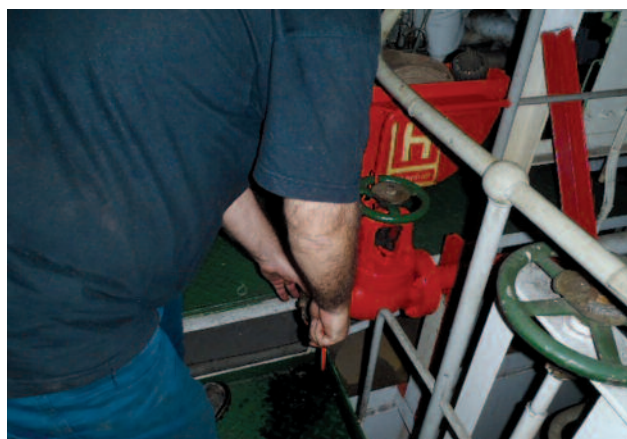
Hydrant cap difficult to remove, and valve leaking

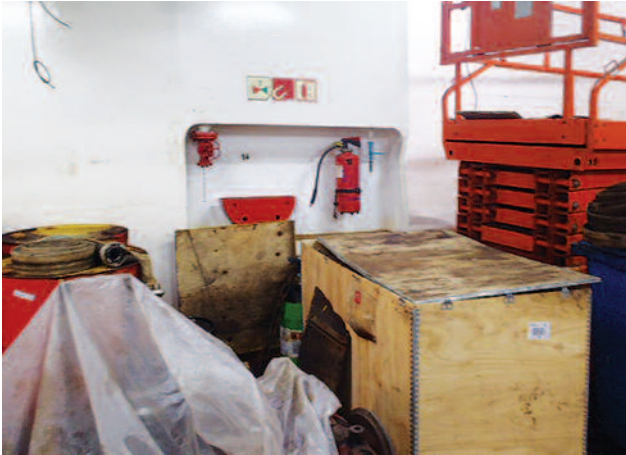
Obstructed FFE

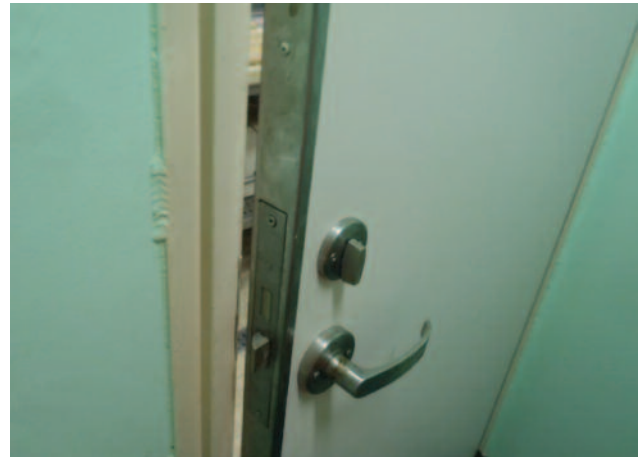
Fire door failing to close

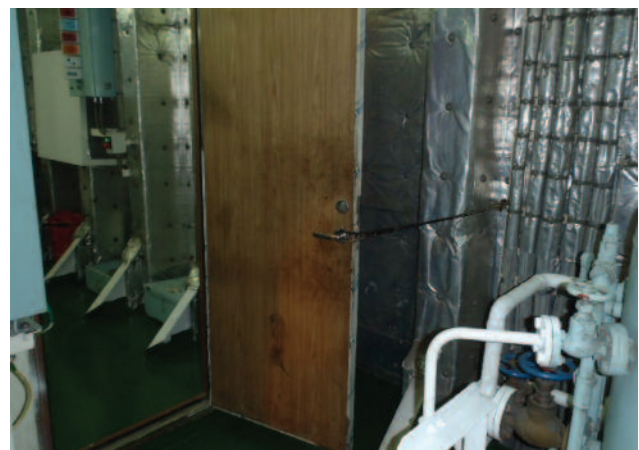
Fire door tied open

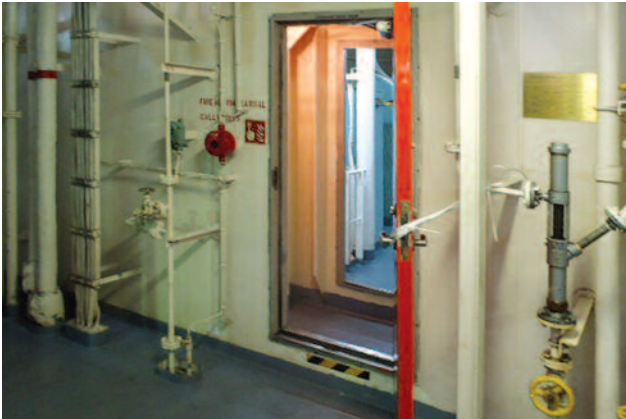
The particular importance of the fire doors between the Engine Room and Steering Gear Compartment should also be emphasised. These are very frequently found to be tied in the open position.

Steering gear fire doors tied open

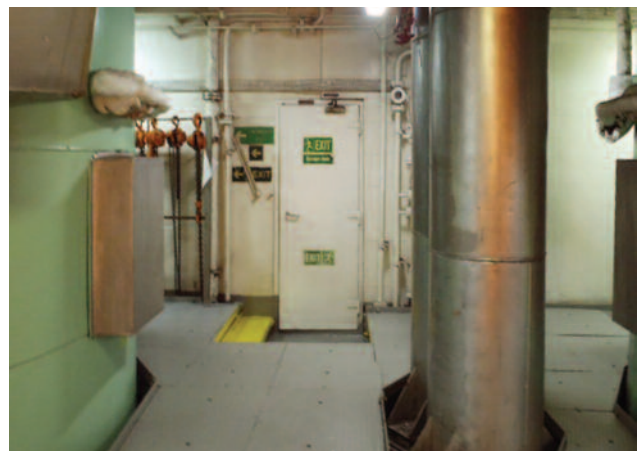
Poorly marked escape route and door

Technical Bulletin No. 39/2007 also recommends that the exit doors are clearly highlighted. In both the above photographs, it can be seen that white painted doors do not stand out well against white painted bulkheads. Doors painted with “tiger stripes” or marked with retro reflective tape are far more obvious.

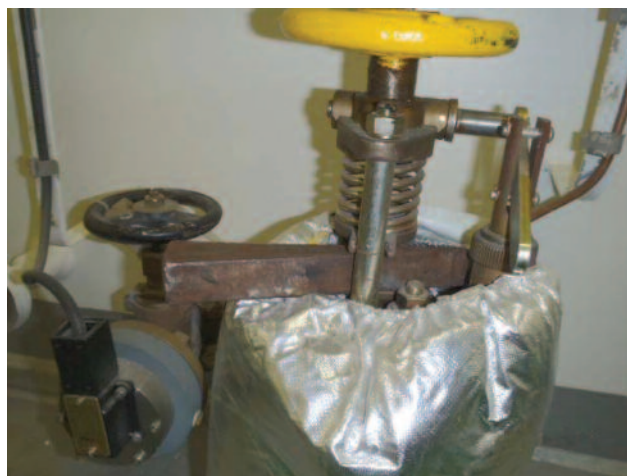
Quick closing valves will not shut if, as sometimes noted, they are tied or wedged in the open position. This is an unnecessary and highly dangerous practice.

Quick closing valve held open with a steel wedge

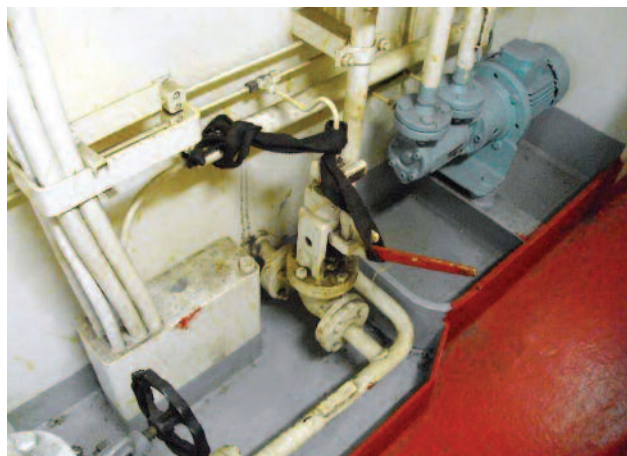
Quick closing valve held open with a strop
