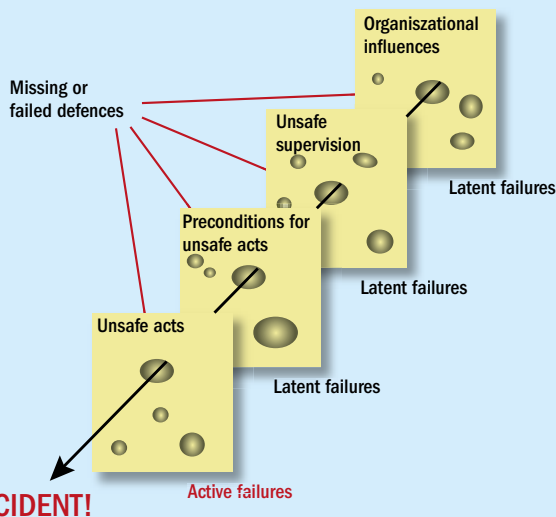
Reading the report, you are led through a series of failures of the Swiss Cheese model (see diagram below) where each defence which has been breached, no matter how minor, could lead to an injury or worse. The more defences that are breached - the more holes in the Swiss Cheese and the greater the likelihood of all of the holes lining up leading to the increased probability of an incident.

Looking more closely at the report to identify the failings, the first part states that oil drums were lifted **unsecured** on a **wooden pallet** using **web stops**. That is three defences breached in less than a dozen words. During the lifting operation the wooden pallet, which **had not been designed for this purpose, began to break up**. The area **had not been barriered off** and **the load passed over the single gangway access** to the vessel which was **not secure**.

Swiss Cheese model showing breaches of defences with potential for an incident

A considered risk assessment treating each lift as an independent operation (i.e. not a generic risk assessment) and backed up by an on-site toolbox talk prior to commencement of an operation, should be able

to eliminate poor seamanship practices, incorrect lifting techniques and incorrect apparatus used for lifting. Training should also be taken into account. It is equally important that the location of the lifting is considered. In this case the load passed over a gangway and the consequences of anybody boarding as the load fails do not bear thinking about - simply due to the area not being cordoned off.
