UK P&I CLUB

RISK FOCUS: ENGINE ROOM FIRES

The majority of onboard fires originate in the engine room

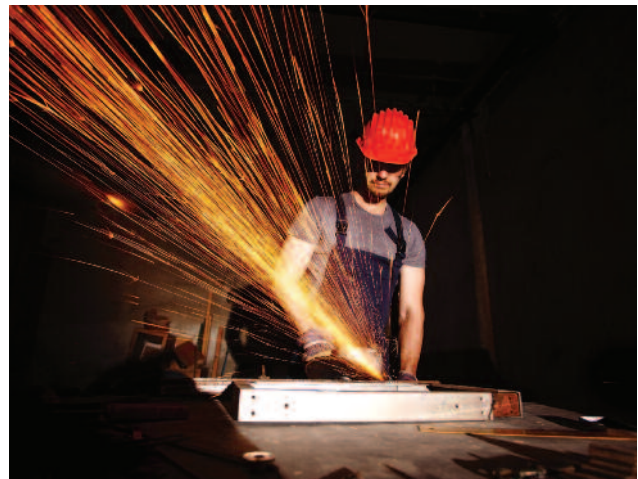
Angle grinding and disc cutting operations should be included in the 'hot work' category because, although the size of incandescent particles produced is generally very much smaller than those produced by welding and flame cutting operations, a stream of grinding or disc cutting sparks landing in the same area of a solid fuel can be sufficient to initiate a smouldering fire. Frictional heating of the work piece may also act as an ignition source, e.g. of oil residues on its surface.

A stream of sparks from disc cutting

Hot work outside the workshop should be the subject of a hot-work permit system. It should be noted that sparks from

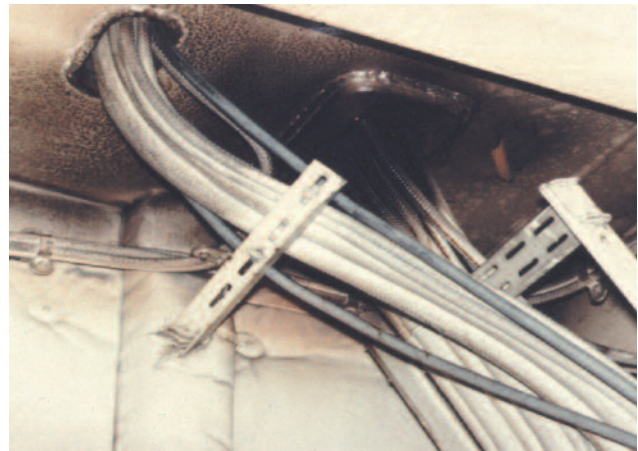
The confluence of electrical cables in distribution boards necessitates a large number of terminal connections to both cable conductors and overload protection devices such as circuit breakers. Inspections of terminal connections and, ideally temperature measurements of the same made by using an Infra-red temperature gun, should form part of shipboard inspection and maintenance programmes. Where multi-stranded electrical conductors are connected to a terminal care should be taken to ensure that there are no stray strands that could inadvertently make contact with another part of the installation. It should be established that all switchgear is clean and circuit breakers are in good condition. Fire stopping around cable glands should be in good condition to minimise the risk of a fire spreading from the distribution board to surrounding areas.

Cables entering a distribution board through fire stopped openings in the casing

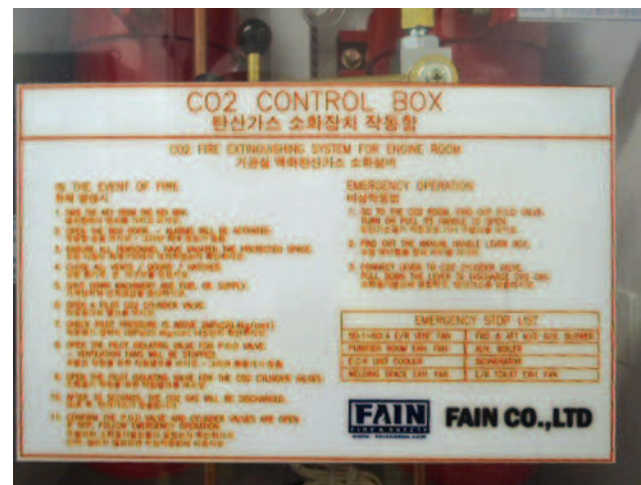
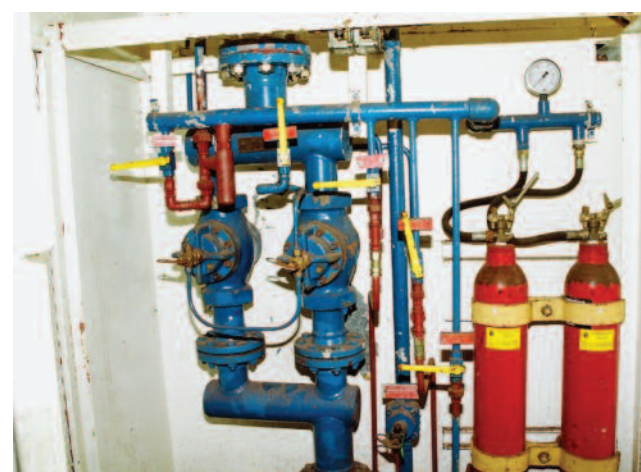
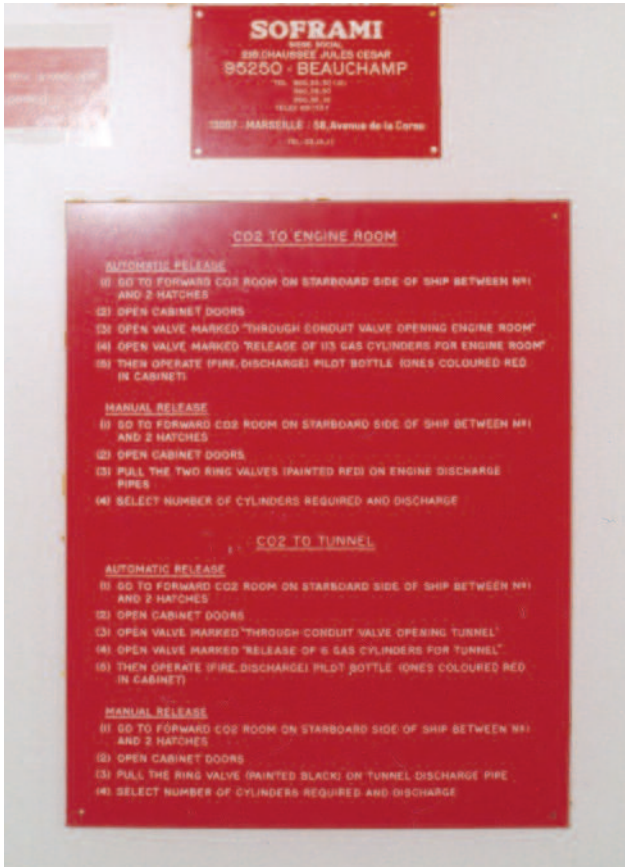
Instructions to operate CO₂ systems can be complicated and valuable time will be wasted if it is necessary to read these for the first time in order to activate the system. Fire drills should include rehearsing the sequence in which the necessary operations should be carried out to activate the systems, including the importance of stopping fans and closing engine room ventilation dampers. In one instance, an electrician was instructed to activate the CO₂ system but, with no previous knowledge or training, did so incorrectly.

After a CO₂ system has been activated in accordance with operating instructions, it is prudent to check that the pilot bottles have operated and the requisite number of cylinders has discharged. This can be done by visually inspecting the cylinder release mechanisms to determine that they are in the activated position. It is important to bear in mind, however, that leaks from the activated system can occur which may reduce the oxygen concentration in the cylinder storage room. For this reason crew members should be ready to perform enclosed space entry procedures with self-contained breathing apparatus sets when undertaking such checks. Automatic fire suppression systems, such as local application high pressure water mist systems, can be used in the auto or manual modes. However, in order for such systems to be most effective they should be left in the auto-mode and the smoke and flame detection systems that trigger their operation should be active and fully operational. Valves in pipework feeding these systems should be kept open.

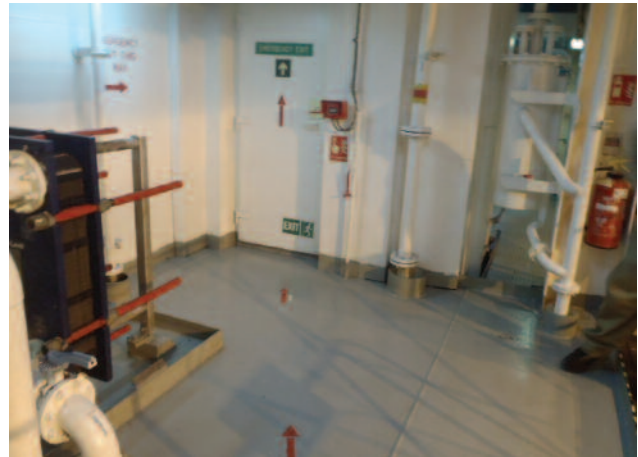
In the UK Club Technical Bulletin No. 39/2012 (Escape from Engine Rooms) it is suggested that arrows are painted on the deck plates pointing to the nearest escape route. This good practice is commonly seen on UK P&I Club ships, but sometimes the arrows could be laid out more clearly. The photographs show excellent arrows leading to the escape trunk, but none to the steering gear compartment which is an alternative escape route.

Well marked escape route arrows

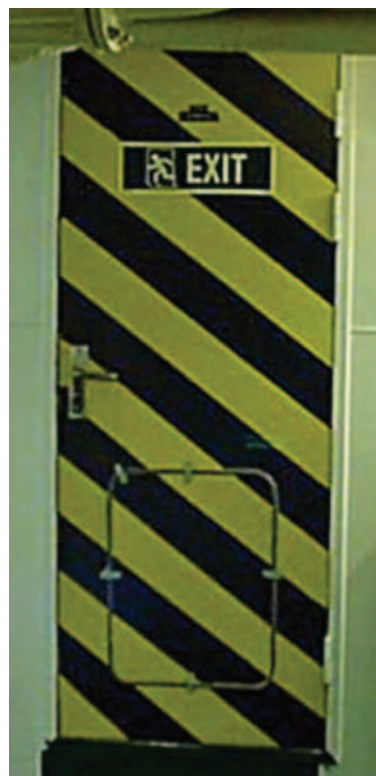
Well marked door

Technical Bulletin No. 39/2007 also recommends that the exit doors are clearly highlighted. In both the above photographs, it can be seen that white painted doors do not stand out well against white painted bulkheads. Doors painted with “tiger stripes” or marked with retro reflective tape are far more obvious.

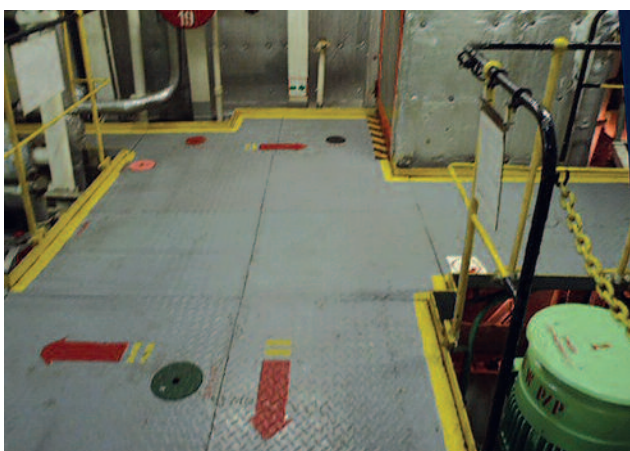
The best escape route from an engine room fire will depend on the location of the fire and its severity and so it is, therefore, difficult to generalise. However, careful thought should be given when marking emergency escape routes and these should not be confused with normal exit routes. In a fire situation, the safest escape route may not be via the internal ladders leading up to the accommodation exits, but sideways (or even downwards) via the escape trunk, the steering gear room or other “safe” areas such as shaft tunnels and side passageways.

Arrows leading away from exit door
